**Final Report on the
I-129 Missouri River Bridge
Deck Condition Assessment Using Non-Destructive
Testing Methods**

Bridge No. 9700.0S129, Sioux City, IA

**Final Report
I-129 Missouri River Bridge
Deck Condition Assessment Using Non-Destructive Testing Methods
Bridge No. 9700.0S129, Sioux City, IA**

November 5, 2012

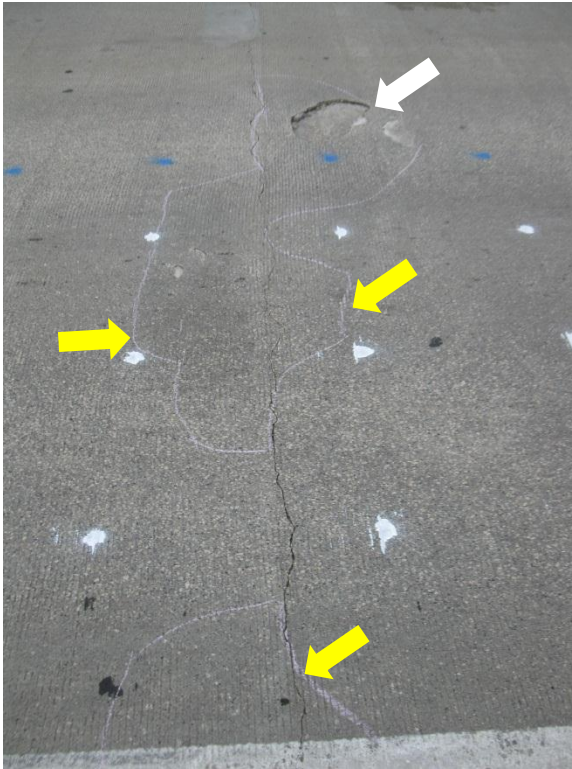
The deck exhibited transverse cracking, and delaminations and spalls likely associated with corrosion of the reinforcing steel (see Figure 2.4). In nearly all cases, the delaminations and spalls coincided with deck cracks as shown in Figure 2.4 or with construction joints in the overlay as shown in Figure 2.5. While the delaminations typically were found on both sides of the cracks, some delaminations occur on only one side of the crack, as shown in Figure 2.6. The observed deck cracks typically range in width from 0.010 to 0.030 in., whereas the construction joints in the overlay were generally tighter in width (0.010 in. or less). The observed cracks are likely related to early age shrinkage or thermal contraction of the deck concrete that occurred soon after construction of the deck but prior to casting of the overlay. Where relative movement occurred at such deck cracks after the overlay was cast, those cracks would have reflected through the overlay and been visible during our inspection. However, some of the observed cracking may have been caused by differential shrinkage or thermal contraction between the overlay and deck concrete, in which case they would be limited to the depth of the overlay.

Figure 2.4. Typical delamination (highlighted with chalk) of concrete at a crack. Surface spalling is also visible (white arrow).

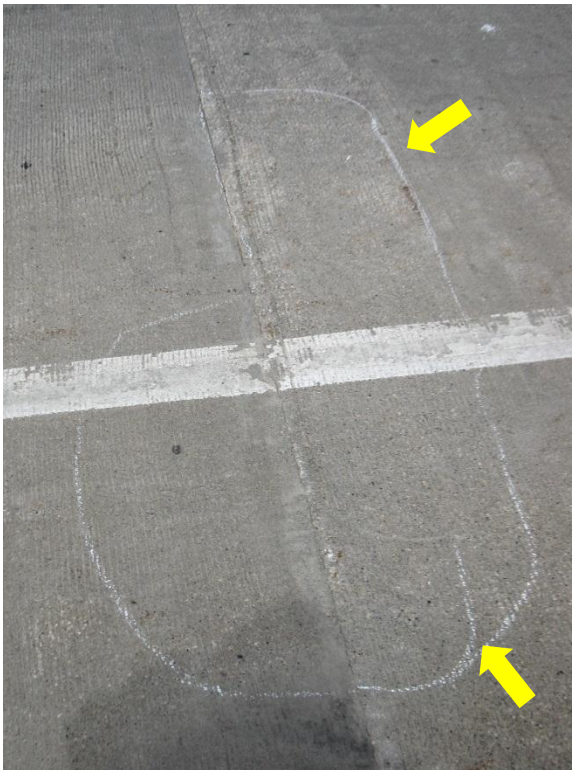
Some of the areas where delaminated concrete was identified may actually be associated with debonding of the overlay from the underlying deck slab concrete. Debonding of the overlay would be more likely to occur adjacent to construction joints in the overlay or at cracks, where the stresses in the bond line due to drying shrinkage of the overlay and thermal changes are increased because of the discontinuity in the overlay concrete. However, such debonding along the construction joints in the overlay was found to be limited in this study, implying that most of the delaminations adjacent to cracks are associated with corrosion of the reinforcing steel at the crack.

Figure 2.5. Delamination (highlighted with chalk) of concrete at a construction joint in overlay.

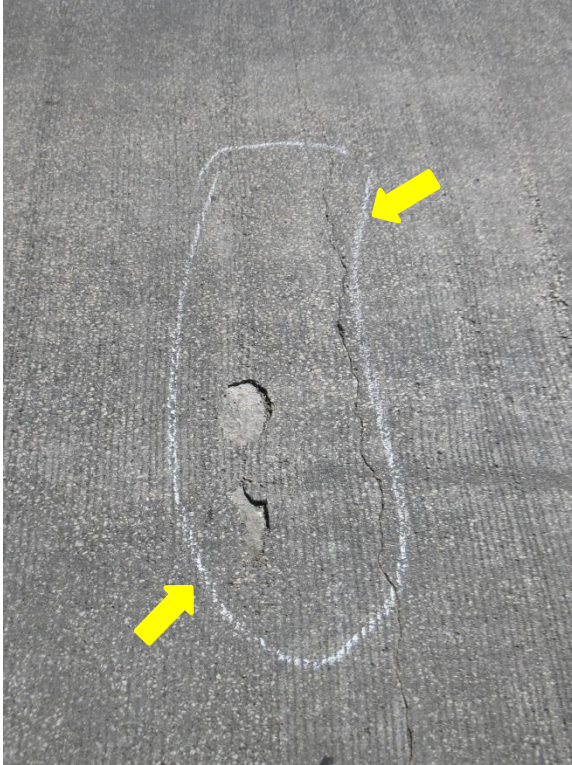
Figure 2.6. Delamination (highlighted with chalk) of concrete on one side of crack.

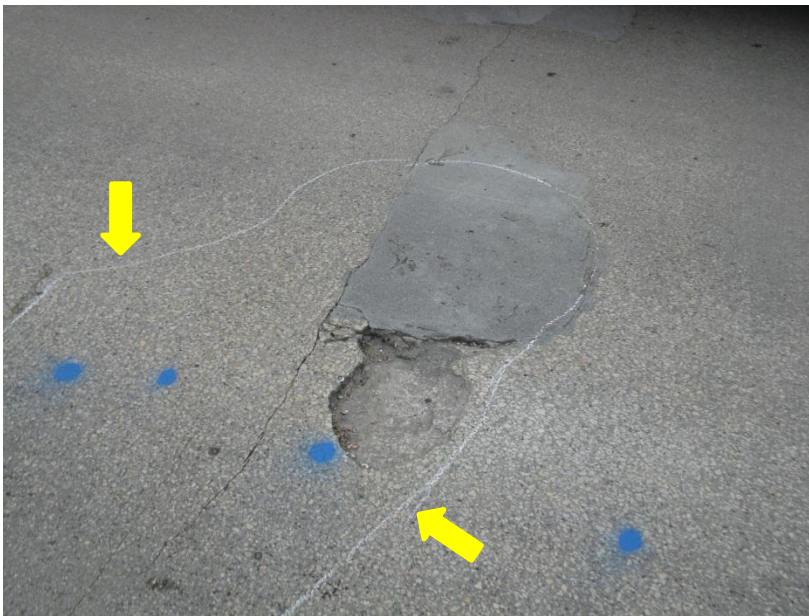
Several conventional patch repairs (see Figure 2.7) and the remains of multiple epoxy injection repairs (see Figure 2.8) were visible on the deck surface. It appears that the epoxy injection may have been used to treat cracks as well as to fill delaminations. In some cases, delamination continues to occur around the periphery of numerous delaminations injected previously with epoxy. However, it appears that the epoxy injection was reasonably successful at re-establishing bond at some locations where delaminations were present in 2008, and may also have reduced the quantity of delaminations that progressed to spalls.

Figure 2.7. Existing concrete patch repair and cracking of deck. Note adjacent spall and new delamination (arrows) outlined in chalk.

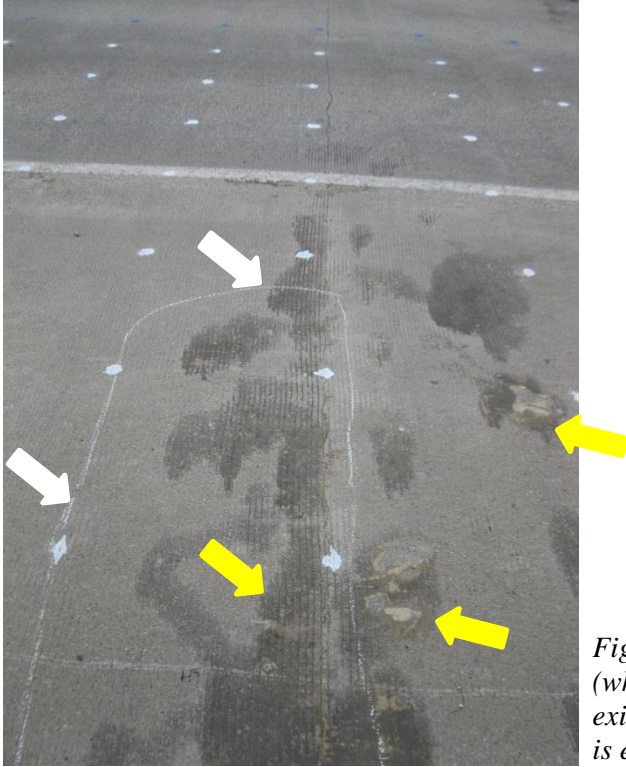
Figure 2.8. Delamination of surface concrete (white arrows) along crack where evidence of existing epoxy injection repairs (yellow arrows) is evident.

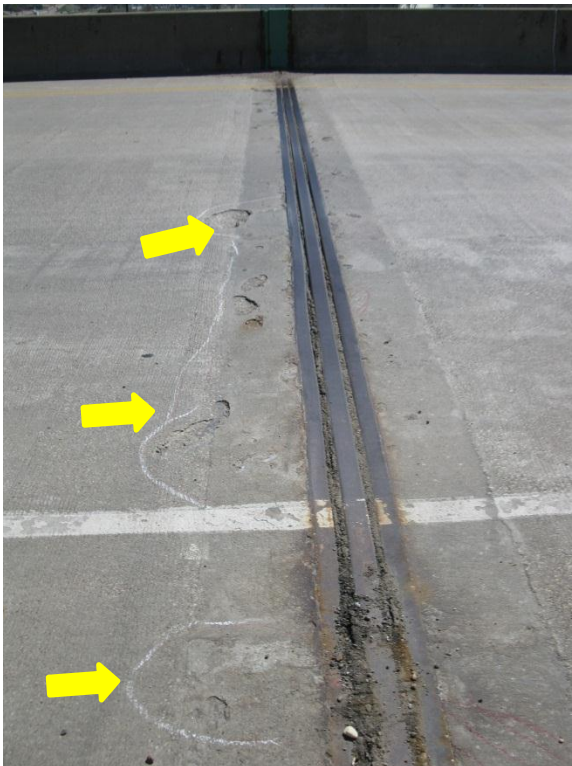
Figure 2.9. Typical delamination of concrete deck surface (highlighted in chalk) near a modular expansion joint seal system.

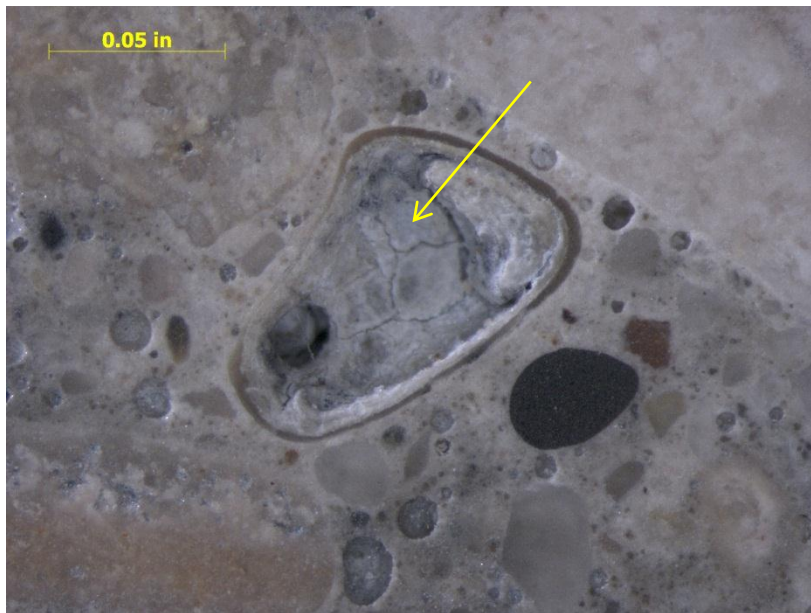
Figure 5. Core 6 topping; the largest reacted fine particle of shale (encircled in Figure 2) located in close proximity to the intercepting microcracks. Most of the interior of this particle has been consumed in the alkali-silica reaction; gel was found on the surfaces of the microcracks.

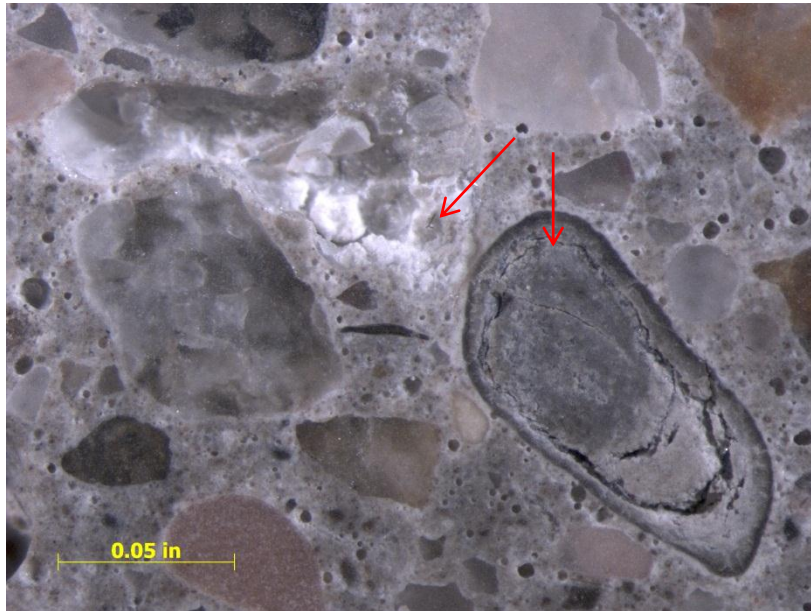
Figure 6. Core 6 base concrete; shown is the largest sand particle of reactive shale. White ASR gel partially fills large air void that is adjacent to the particle. Cracks are present within the shale particle but they do not extend to the surrounding cement paste.

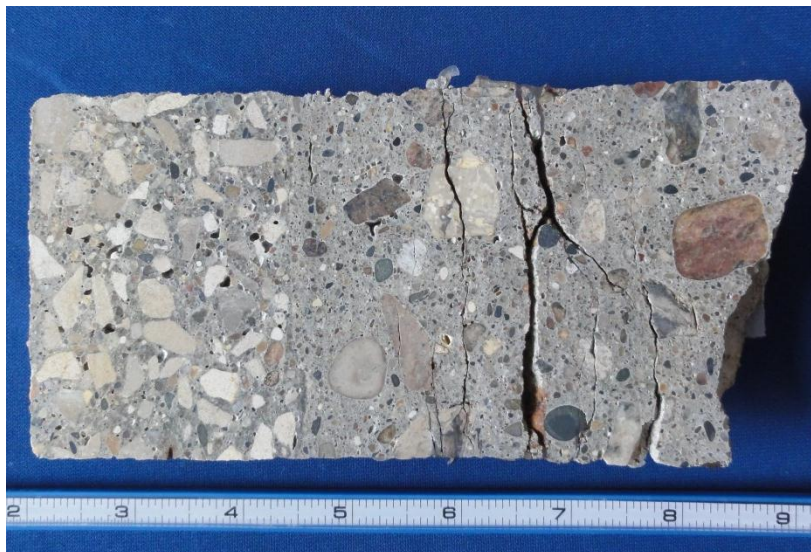
Figure 7. Lapped section of Core 42; top end is on the left of the photo. Numerous cracks due to corrosion and ASR are present in the base concrete; no cracking was detected in the topping concrete.

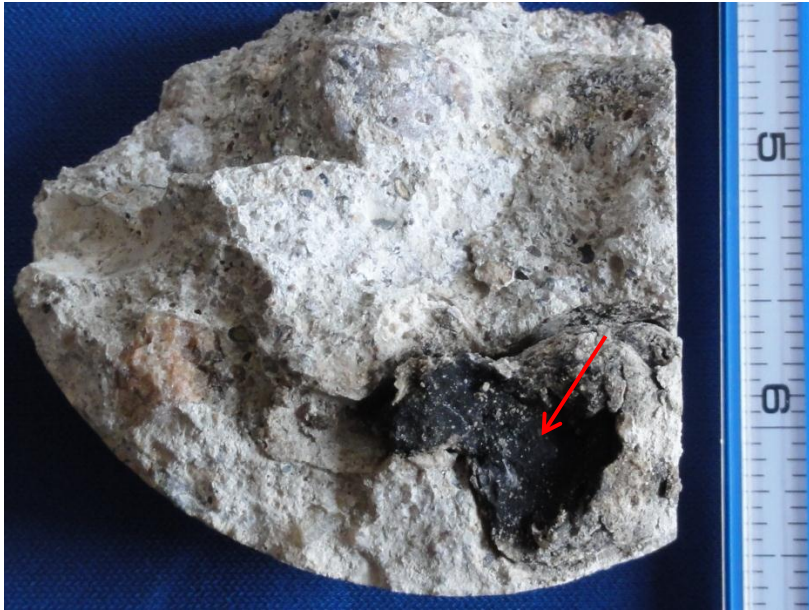
Figure 10. Core 42; large lump of industrial waste containing reactive glass embedded at the bottom of the base concrete.

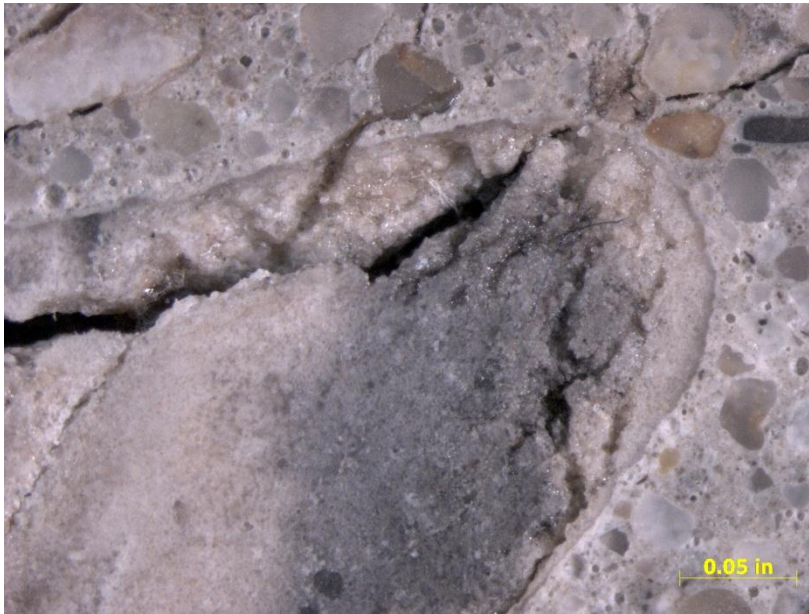
Figure 12. Core 42 base concrete; reactive sandstone particle, partially consumed in ASR; cracks extending into the surrounding cement paste.

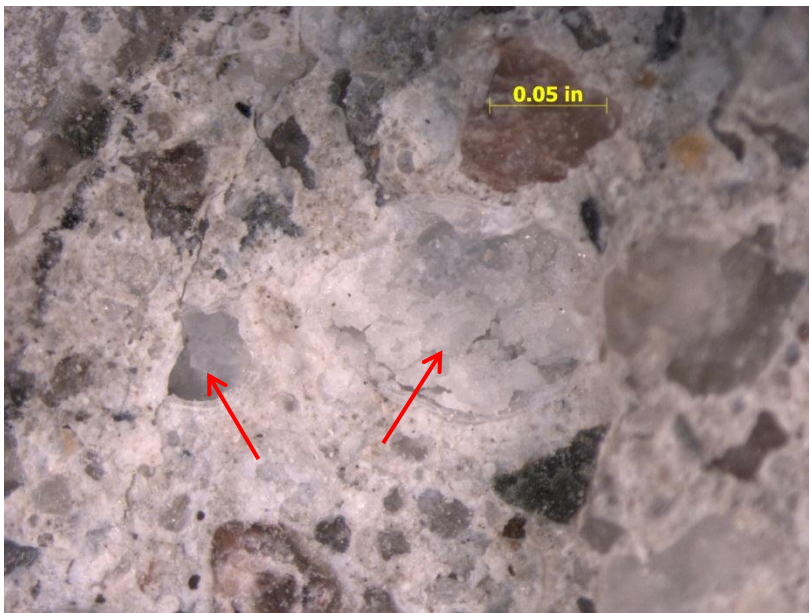
Figure 13. Core 42; air voids partially filled with ASR gel at one of the crack surfaces in the base concrete.
